Cable Median Barrier Program in Washington State

WA-RD 812.1

WSDOT Research Report

CABLE MEDIAN BARRIER PROGRAM IN WASHINGTON STATE

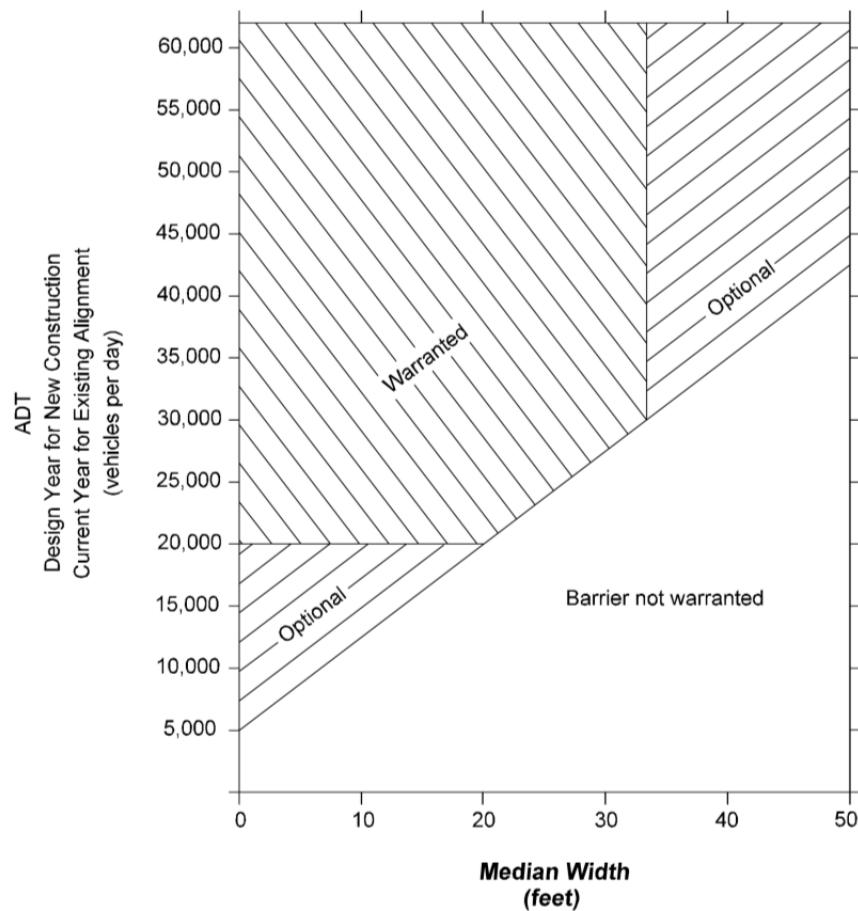
Figure 2.1 Warrants for median barrier (from 2001 *Design Manual* guidance)

An Instructional Letter was issued in August 2001 to revise the WSDOT *Design Manual* guidance for the use of median barriers. That letter implemented the recommendations of the *Median Treatment Study on Washington State Highways*. Soon after the issuance of the August 2001 Instructional Letter, WSDOT Project Development personnel began to raise questions about how to implement the new policy for those projects that were previously programmed with no money budgeted for median barrier. Consequently, a revised Instructional Letter was issued in November 2001, which provided clarity for dealing with previously programmed projects. *Design Manual* Figure 700-7 was deleted by guidance in the August 2001 and November 2001 *Design Manual* Supplements.

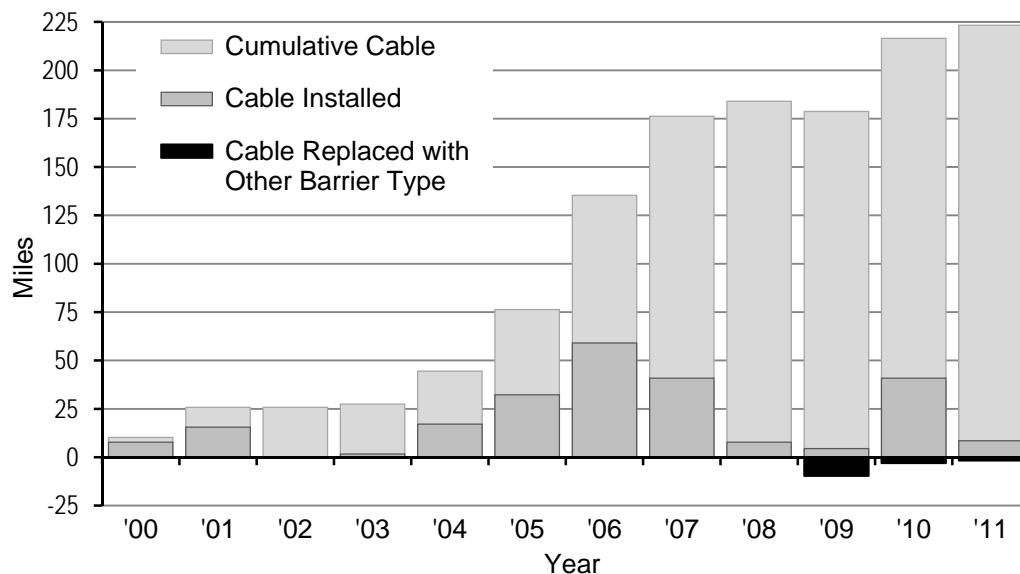
Figure 3.1 Miles of cable median barrier installed

By the end of 2011, there were nearly 225 miles of cable median barrier still in place and another 3.34 miles were under contract for installation. The 224.92-mile total includes 1.63 miles that were installed too late in 2011 for inclusion in the performance analysis. Another 14.89 miles of cable barrier had been installed that, for various reasons, were replaced by other barrier systems over the years. This accounts for the cumulative dip in 2009. The most common situation was a condition where traffic lanes were added to the median side of the highway, which reduced the median width. Because narrow medians restrict the allowable deflection distance of barriers and complicate repairs, cable barriers were replaced with more rigid concrete barriers, which require less deflection and have less frequent need for repair. The cable barrier performance on these since-replaced miles is still included, thus making the total covered in this report 238.18 miles. This performance report total includes 35.53 miles where cable barrier systems were upgraded to another cable barrier system, usually from a low-tension to a high-tension system.

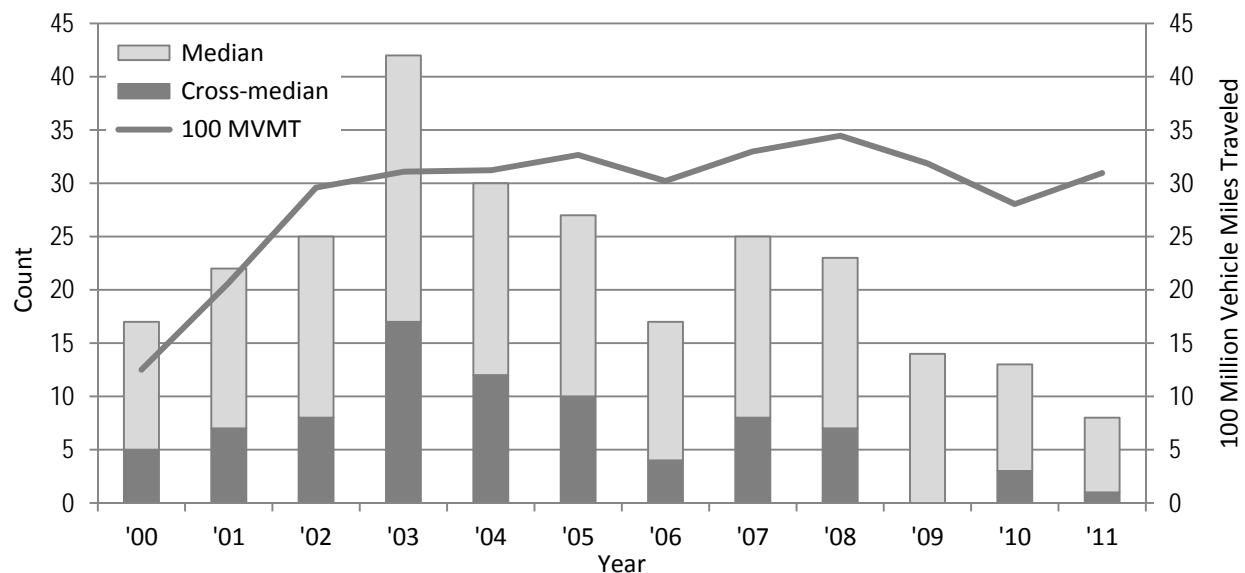
Figure 3.2 Median and cross-median fatal and serious injury collisions with vehicle miles traveled

The full measure of effectiveness with median barriers is the overall impact on fatal and serious injury collisions. While cross-median collisions are an important component in median barrier performance, engineers must look at all collisions involving a barrier system to fully assess performance. Between 2000 and 2011, there was a dramatic decline in fatal and serious injury collisions within or across the median. Figure 3.2 illustrates the number of fatal and serious injury collisions occurring within or across the median where cable barrier had been installed, with a line indicating vehicle miles traveled (both omit the period during barrier installation). The decline in fatal and serious injury collisions corresponds to the increase in miles of barrier placed.

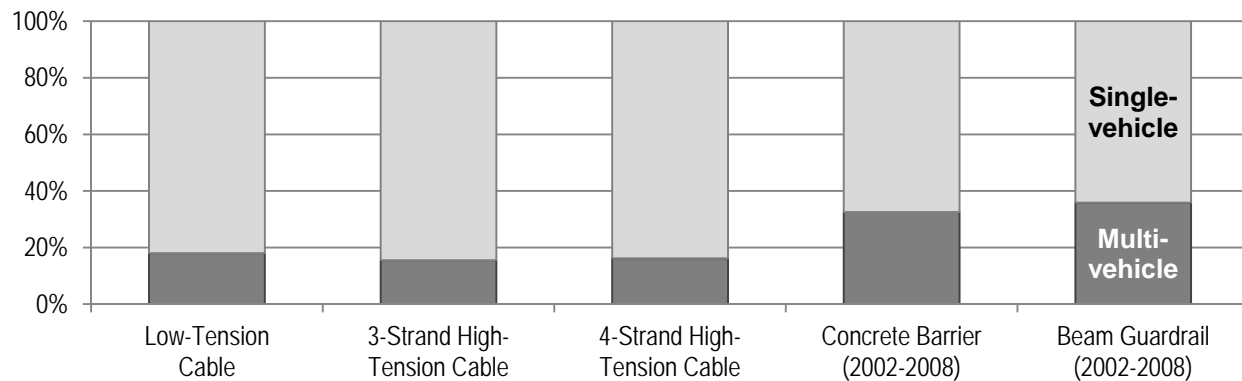
Figure 3.8 Percentage of single- and multi-vehicle collisions with barrier types

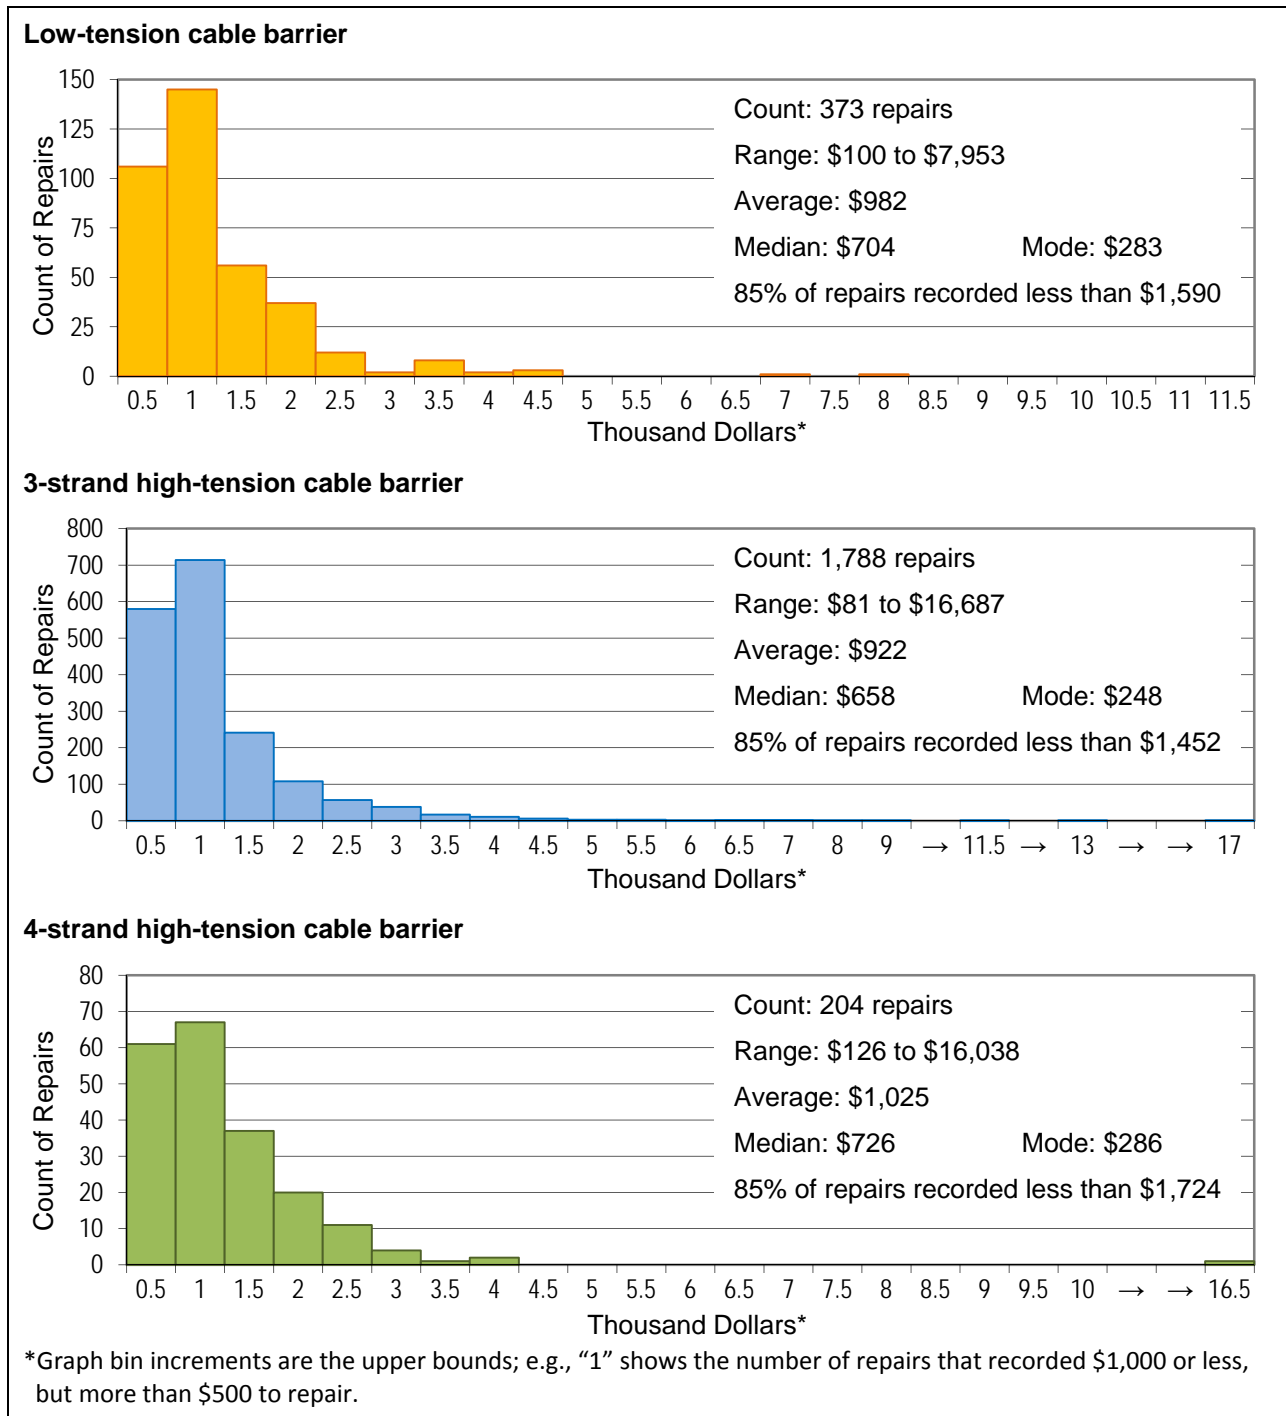
Figure 4.1 Cost per repair by cable barrier type

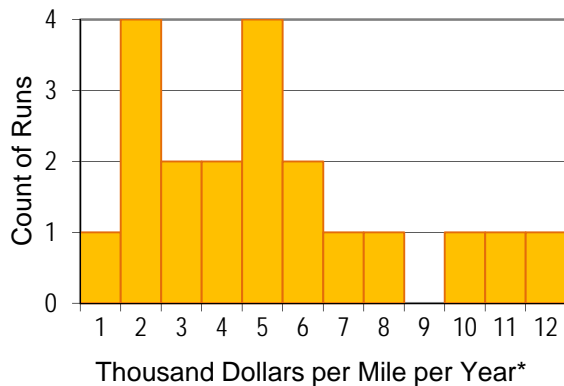
Low-tension cable barrier

Figure 4.2 Repair cost per mile per year by cable barrier type

Count: 20 segments (runs)
Range: \$157 to \$11,318 pmy
Average: \$4,603 pmy
Median: \$4,243 pmy
85% of runs had less than \$7,743 pmy

This summary first totals the cost of all repairs on an individual treated segment, divides that total by the segment's length, and then divides that quotient by years in service, giving the cost per mile per year (pmy) of that segment (run). Figure 4.2 shows the repair cost pmy rate of runs by cable barrier type.

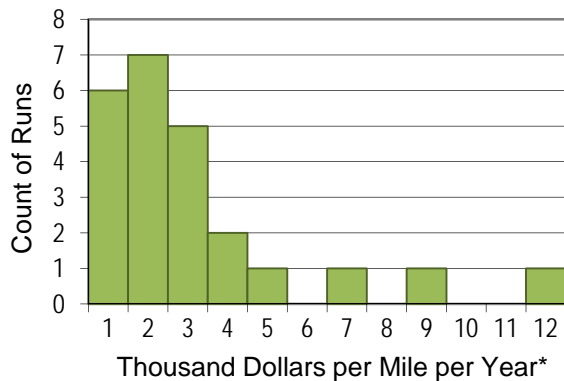
4-strand high-tension cable barrier

Count: 24 segments (runs)
Range: \$58 to \$11,056 pmy
Average: \$2,636 pmy
Median: \$1,898 pmy
85% of runs had less than \$4,209 pmy

*Graph bin increments are the upper bounds; e.g., "2" shows the number of runs rating \$2,000 or less, but more than \$1,000 repairs per mile per year.

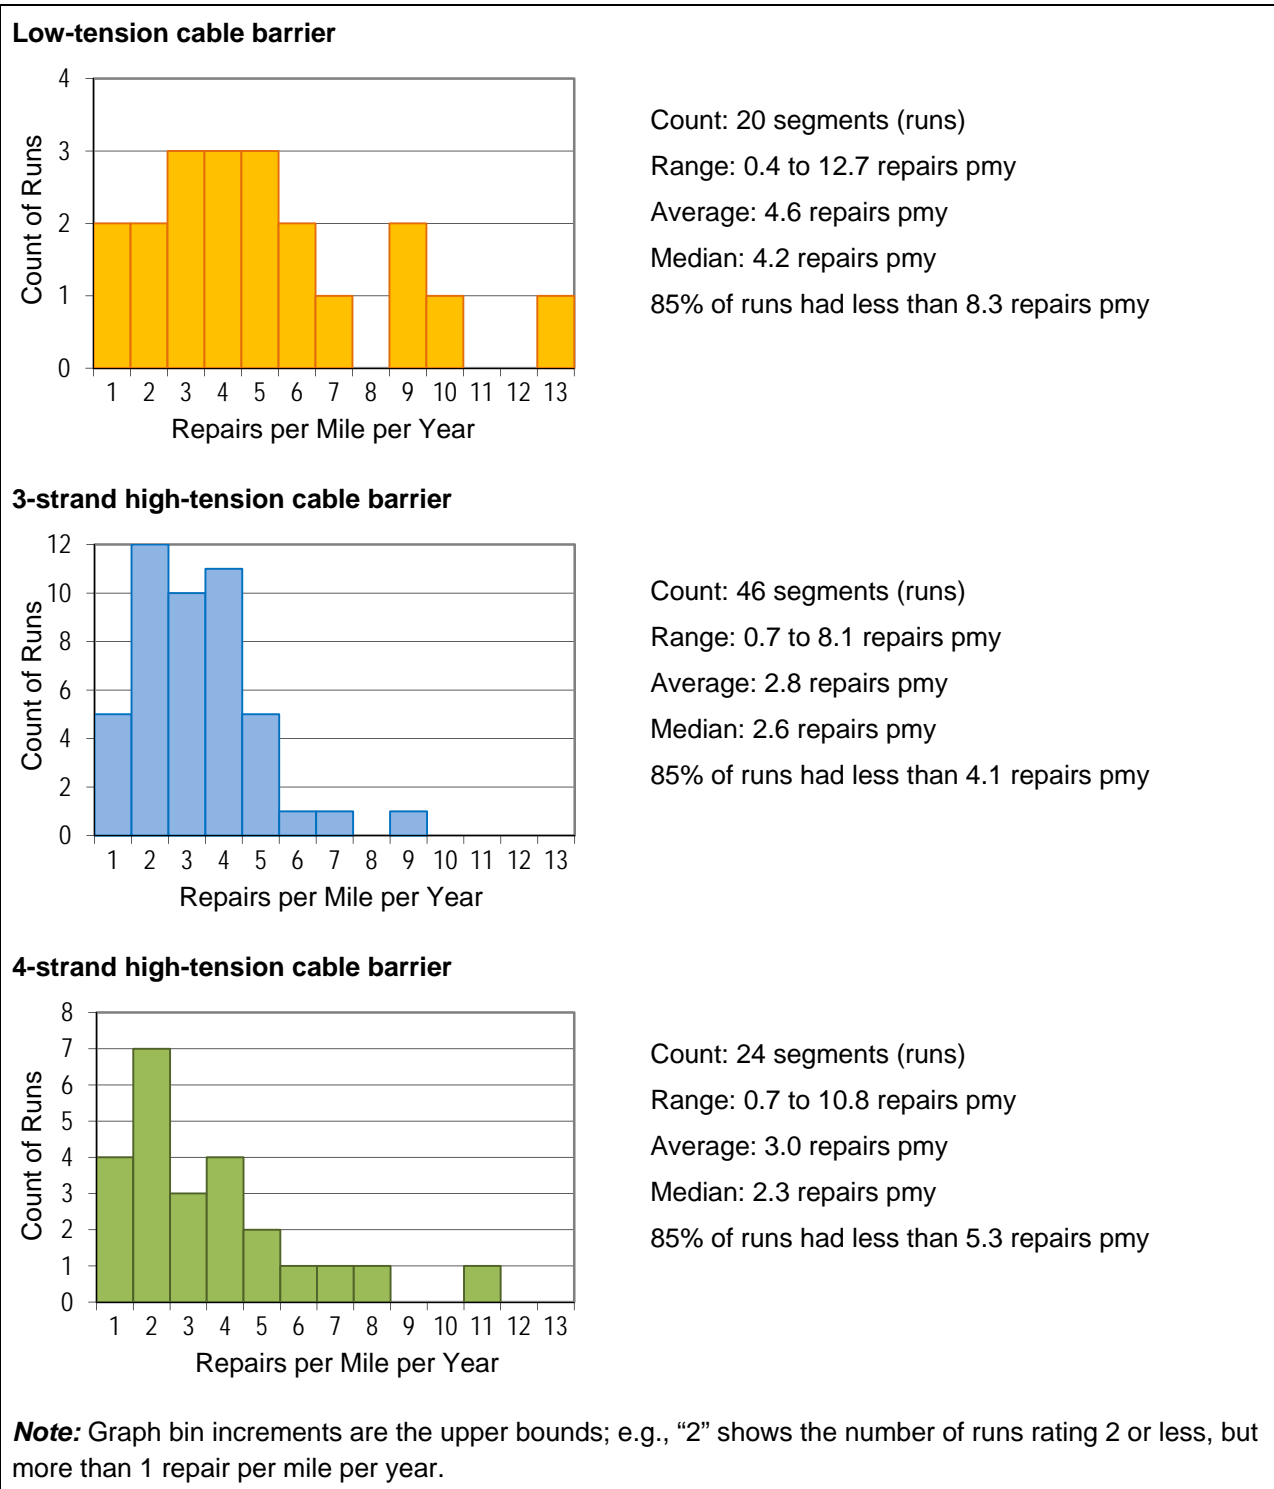
Figure 4.3 Repair frequency per mile per year by cable barrier type

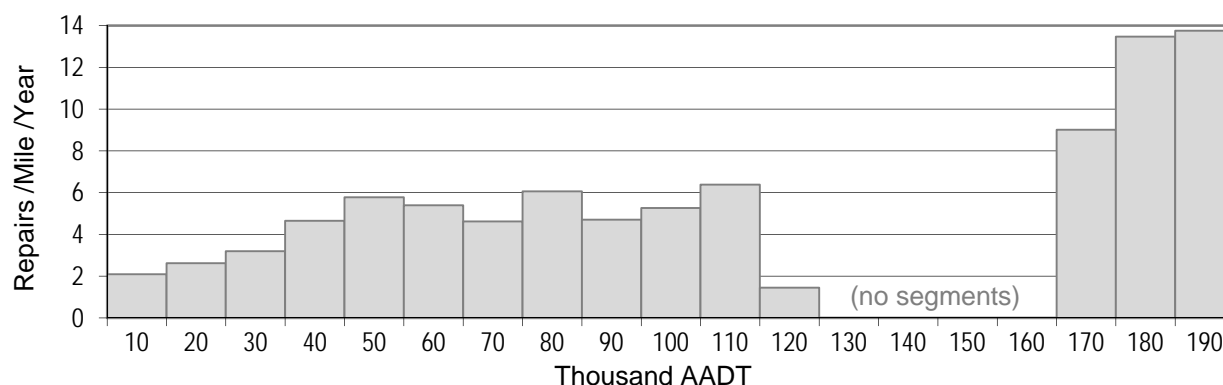
This summary determines the number of repairs per mile per year, without regard to cable barrier type, at estimated annual average daily traffic (AADT) increments, as shown in Figure 4.4.

Figure 4.4 Repair frequency per mile per year by AADT

Note: Graph bin increments are the upper bounds; e.g., “20” shows the repairs per mile per year at 20,000 AADT or less, but more than 10,000.

As expected, the frequency of repairs generally increases with traffic. Anyone using Figure 4.4 to estimate the repair cost per year given a length of highway, its AADT, and a derived cost per repair of a cable barrier type is cautioned that it is composed of an aggregate of sites that vary in median width, number of lanes, posted speed, barrier offset, presence of rumble strips, horizontal alignment, etc. Besides AADT, specific site conditions could affect the frequency of repair.

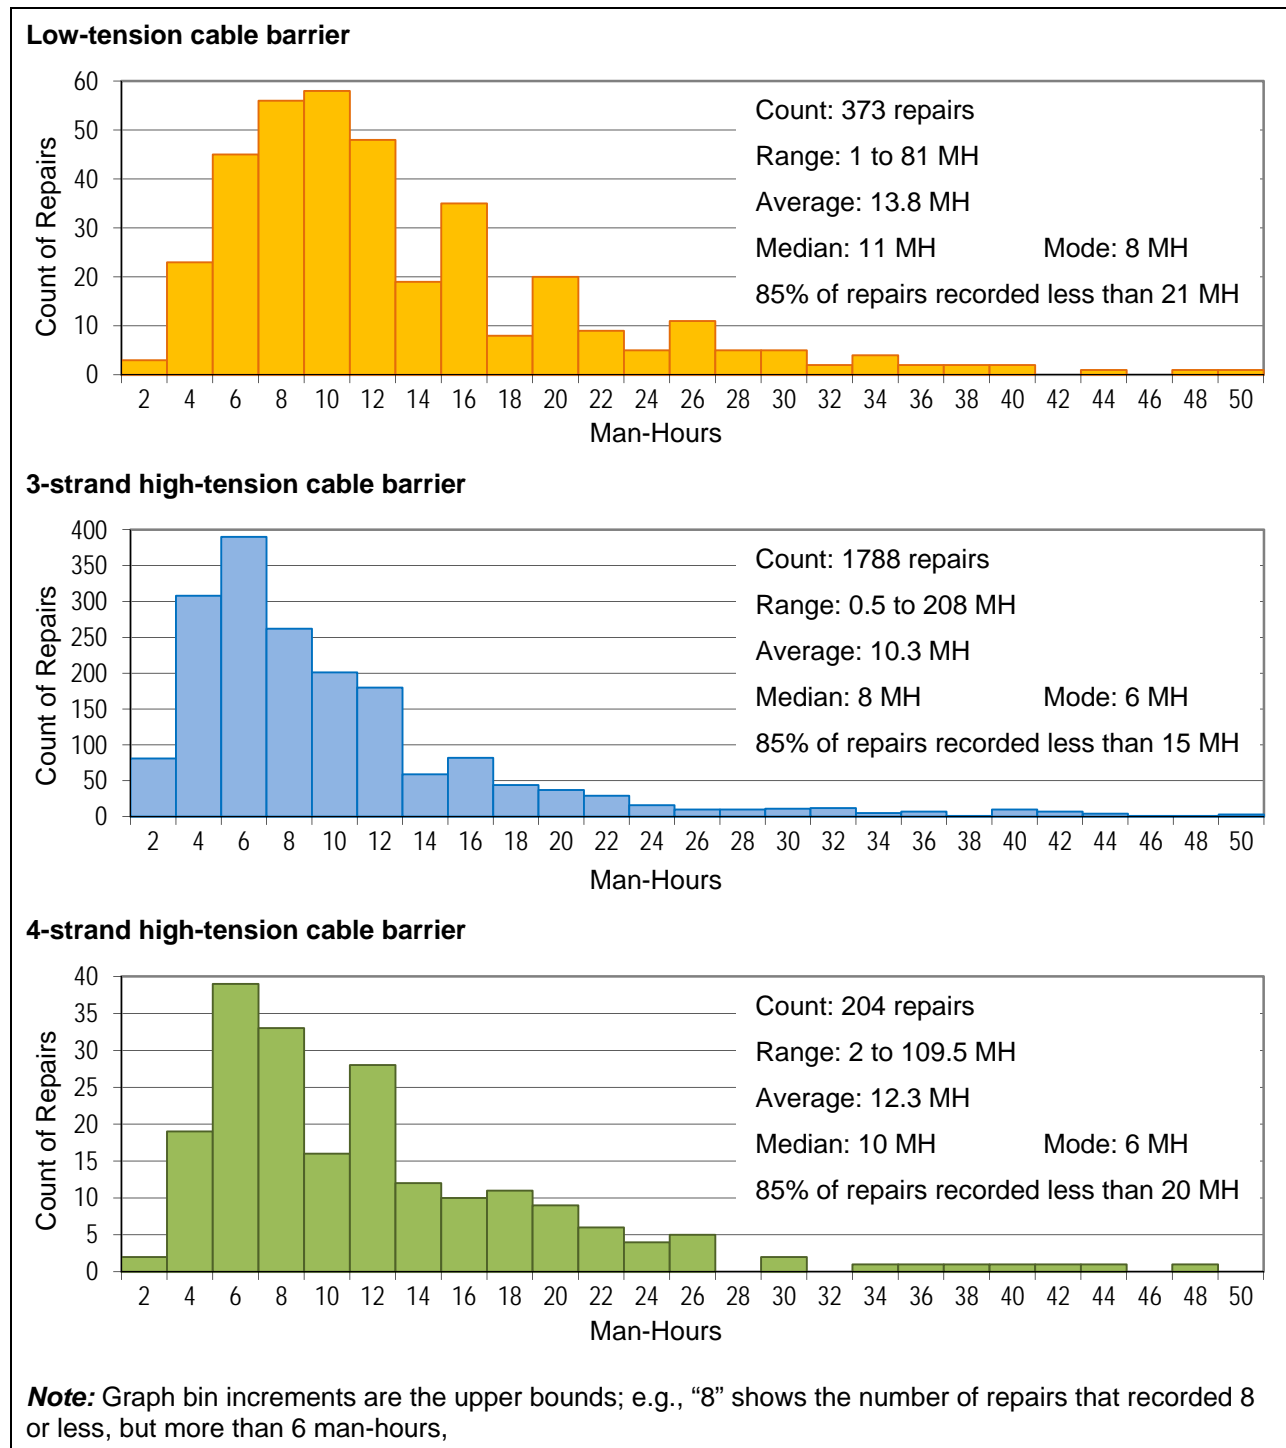
Figure 4.5 Man-hours (MH) per repair by cable barrier type

Figure 4.5 shows that the high-tension systems are recording fewer man-hours to repair. The 3-strand high-tension system appears to require the fewest average man-hours. The 3-strand high-tension repair numbers are nine times that of the 4-strand system, which is a result of being in place over a longer period of time. There is an expectation that, as they spend more time and gain familiarity with the 4-strand system, maintenance crews will reduce the average time required to repair these systems.

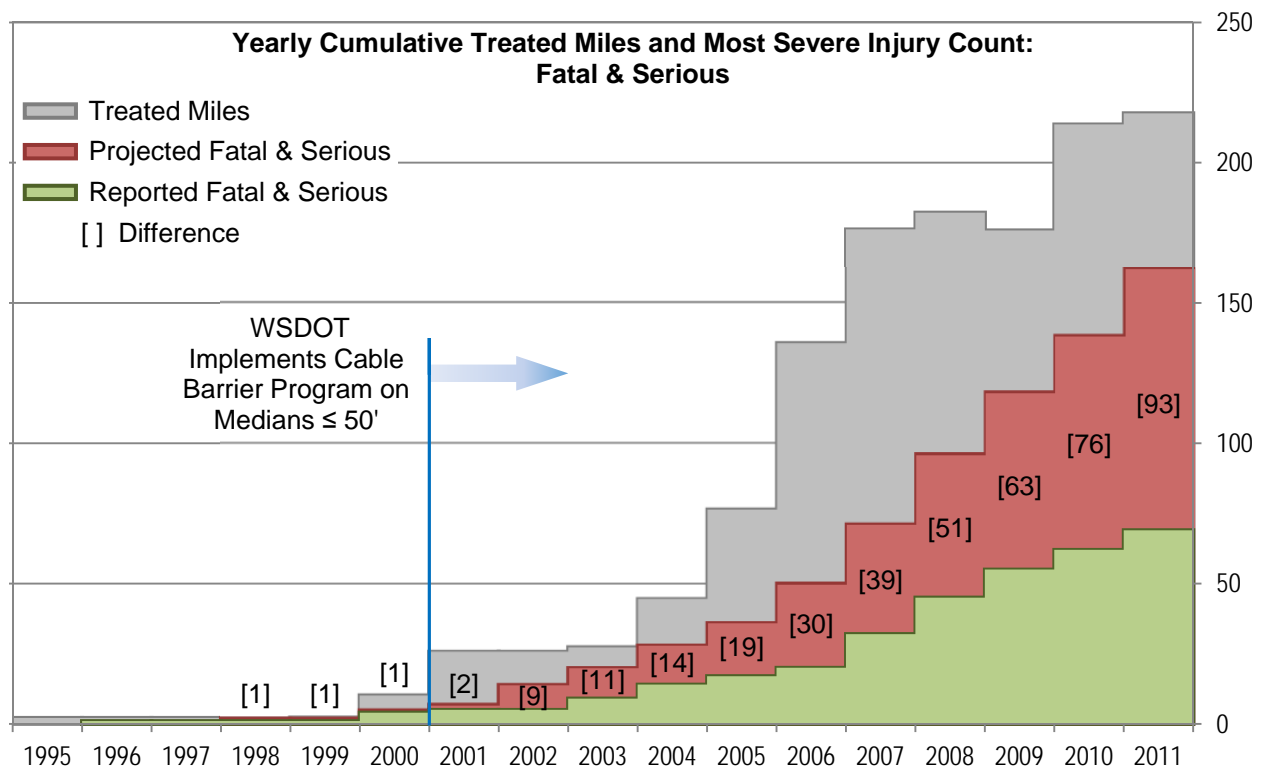
Figure 4.6 Actual performance versus a projected nonbarrier condition

In this comparison, the count of fatal and serious injury collisions in a cable median barrier segment's "before" (installation) period is divided by the duration (usually five years) of that period. This gives a collisions-per-year (CPY) value to the number of collisions that would have occurred in each following year had cable median barrier not been installed on those miles (i.e., projected fatal and serious injury collisions).

Figure 4.6 shows the per year projected fatal and serious injury collision count (red) on a backdrop of cumulative cable median barrier miles installed (gray). As the years progress, more segments (miles) are installed and their respective CPY values are calculated and added to those already established, cumulatively at each year. In contrast (green) are the actual reported fatal and serious injury collision cumulative counts. The difference is given in [brackets]. This suggests that the WSDOT cable median barrier network, in its history, has deterred over ninety-three fatal and serious injury collisions.

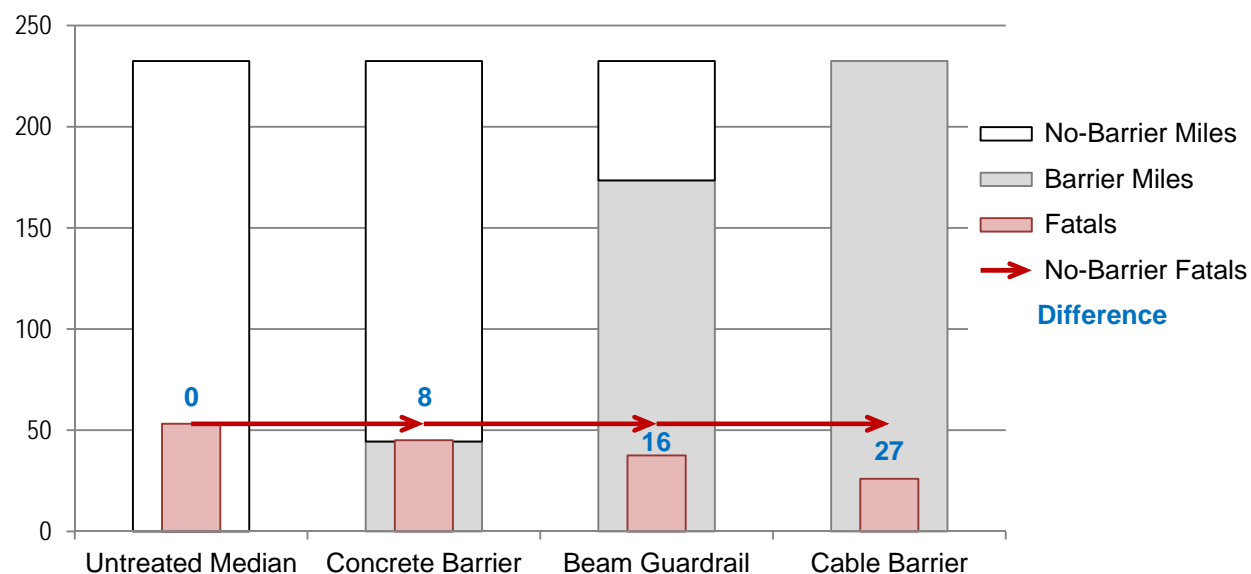
Figure 4.7 Projected fatalities across barrier types and miles

Figure 4.7 indicates that cable median barrier performance and low-cost per linear foot allowed a greater impact in reducing fatal collisions that may have occurred. In comparison to concrete median barrier, WSDOT was able to install over four times the miles and positively affect over three times the number of drivers who may have perished in a cross-median collision had concrete barrier been installed instead of cable barrier.
