PUBLISHED PROJECT REPORT PPR159

Investigation into ‘A’ pillar obscuration – a study to quantify the problem using real world data

By V A Millington, R Cuerden, S Hulse and T Brightman (TRL Limited)

Prepared for: Project Record: S0414/V8, A-Pillar study: An ‘On-The-Spot’ study to quantify the size of the problem

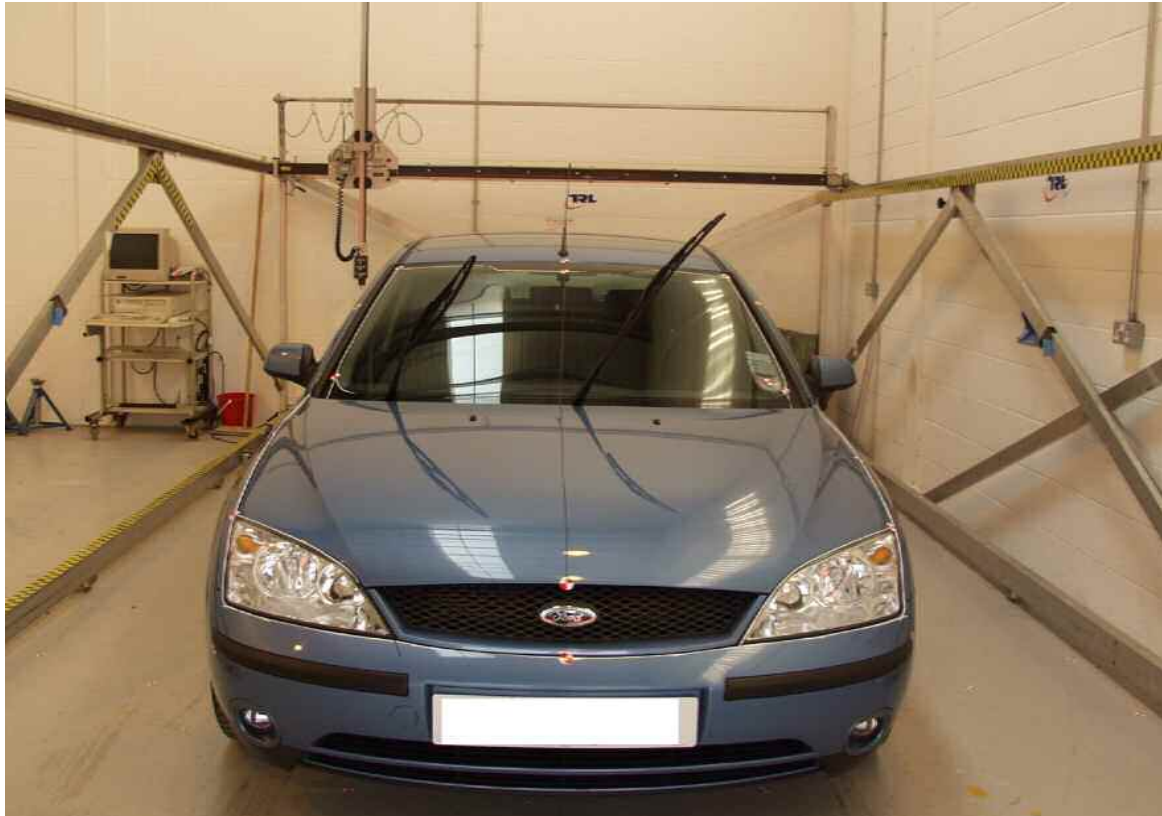
Figure 1: Exterior of a Vehicle Prepared for Digitising

Figures 1 and 2 show some of the taped areas of a vehicle digitized for this study. The output from the FARO arm is a set of 3-D coordinates which can be entered into a CAD package and the coordinates displayed as points, as shown in figure 3.

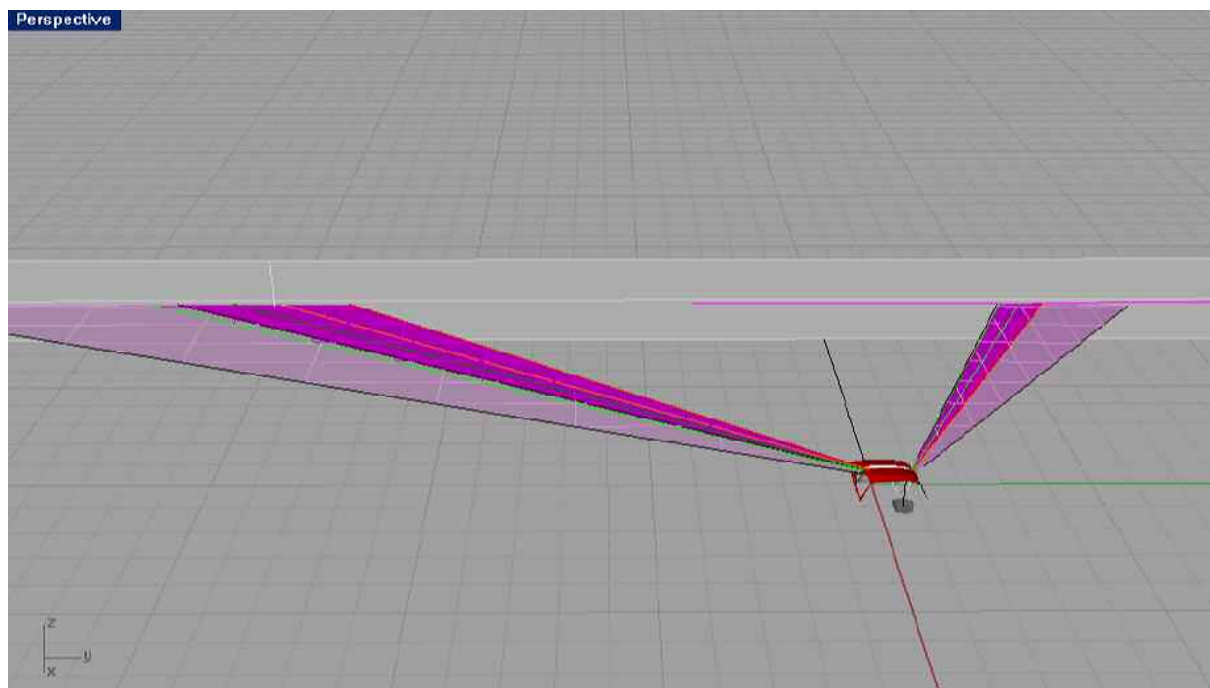
**Figure 9: Validated Angle and Predicted Angles of Obscuration for a 5th Percentile Female**

Test Subject	Angles of Obscuration /°			
	Monocular Offside	Binocular Offside	Monocular Nearside	Binocular Offside
5 th Percentile Female	15.17°	5.51°	8.76°	8.67°
50 th Percentile Male	21.43°	9.76°	11.12°	6.21°
95 th Percentile Male	28.63°	6.92°	15.02°	8.35°

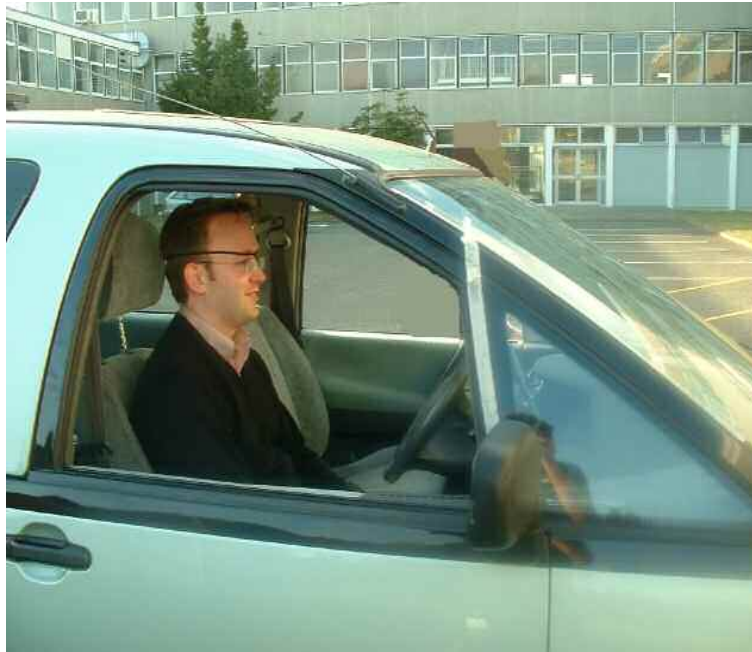
Figure 15: 50th Percentile Male Volunteer in the Toyota Previa

A Toyota Previa was used to represent the MPV class of vehicle for the validation procedure. The design of the front side windows is considered to contribute to a driver's poorer field of view. The style of 'A' pillar is long and raked. The bottom half of the 'A' pillar splits where a vertical support forms the opposite side of a small triangular window, which is intended to aid a driver's field of view.

Figure 15 shows the additional front side window toward the base of the 'A' pillar. The vertical structure for this small window can have the unfortunate effect of acting as an additional 'A' pillar which may further obscure the view of the driver.

The validation procedure incorporated the vertical structure for the small triangular window as part of the 'A' pillar.

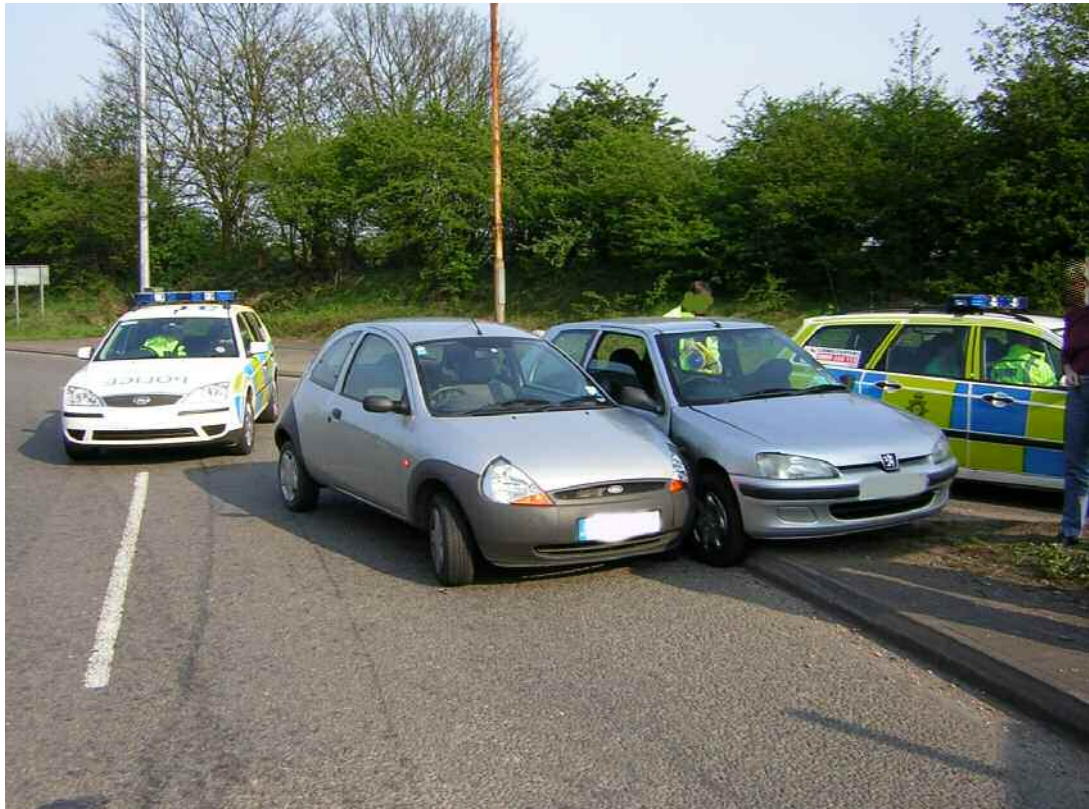
Figure 19: Rest Position of both Vehicles

Reconstructing and modelling the incident has shown the Peugeot 106 to have been partially obscured by the nearside 'A' pillar of the Ford Ka. Both vehicles collided at the exit of the roundabout (see figure 19) and came to rest just past the exit of the roundabout whilst still in contact with each other. The HVE models allowed approximate speeds of the vehicles to be ascertained, which were 17 mile/h for the Ford Ka and 14 mile/h for the Peugeot 106 at the point of impact.

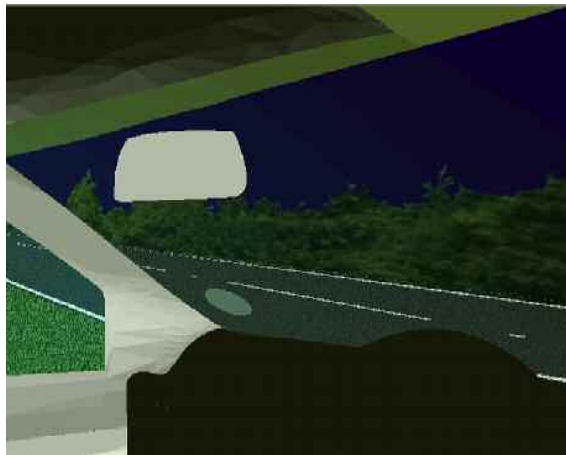
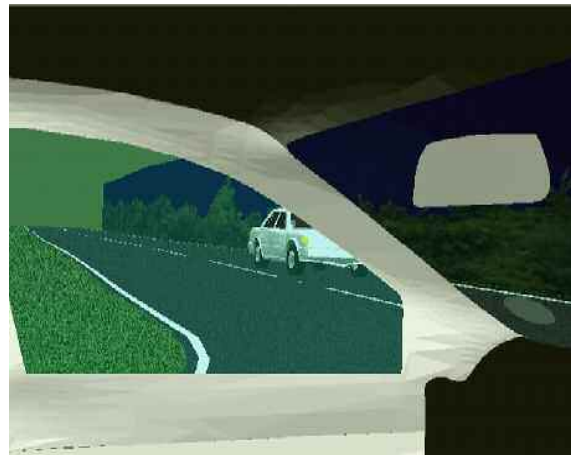
Figures 35 and 36: Driver's View from the Vauxhall Corsa

There is a possibility that 'A' pillar obscuration played a part in this collision, and if so, this would suggest the diffusion from headlights does not give as great a visual clue to motorists as was previously thought. However, this may have been due to the weather conditions which could have lessened the effects of light diffusion. The visualisations show the approaching vehicle was obscured by the nearside 'A' pillar of the Vauxhall Corsa for up to three seconds.

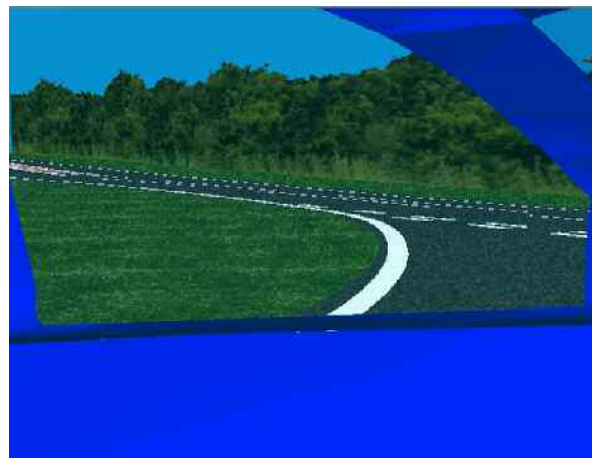
Figures 39 and 40: The View from the Perspective of the Driver of the Ford Mondeo as she Approaches the Junction

The subsequent reconstruction and 3-D visualisation of the accident does tend to confirm the Mondeo driver's view of the accident. The combination of the junction and the small size of the oncoming vehicle strongly suggest the motorcycle was obscured by the offside 'A' pillar of the Mondeo. The shape of the minor road bends to the left as it joins the major road. Figures 41 and 42 show what the driver of the Mondeo may have seen when she turned her head to look left; her field of view would incorporate the nearside side window. However, by turning her head a similar amount to the right (see figures 43 and 44), her view would have been obscured by the offside 'A' pillar. To clearly see her intended path and the approaching motorcyclist, she would have needed to lean forwards or backwards to make a conscious effort to look around the 'A' pillar.

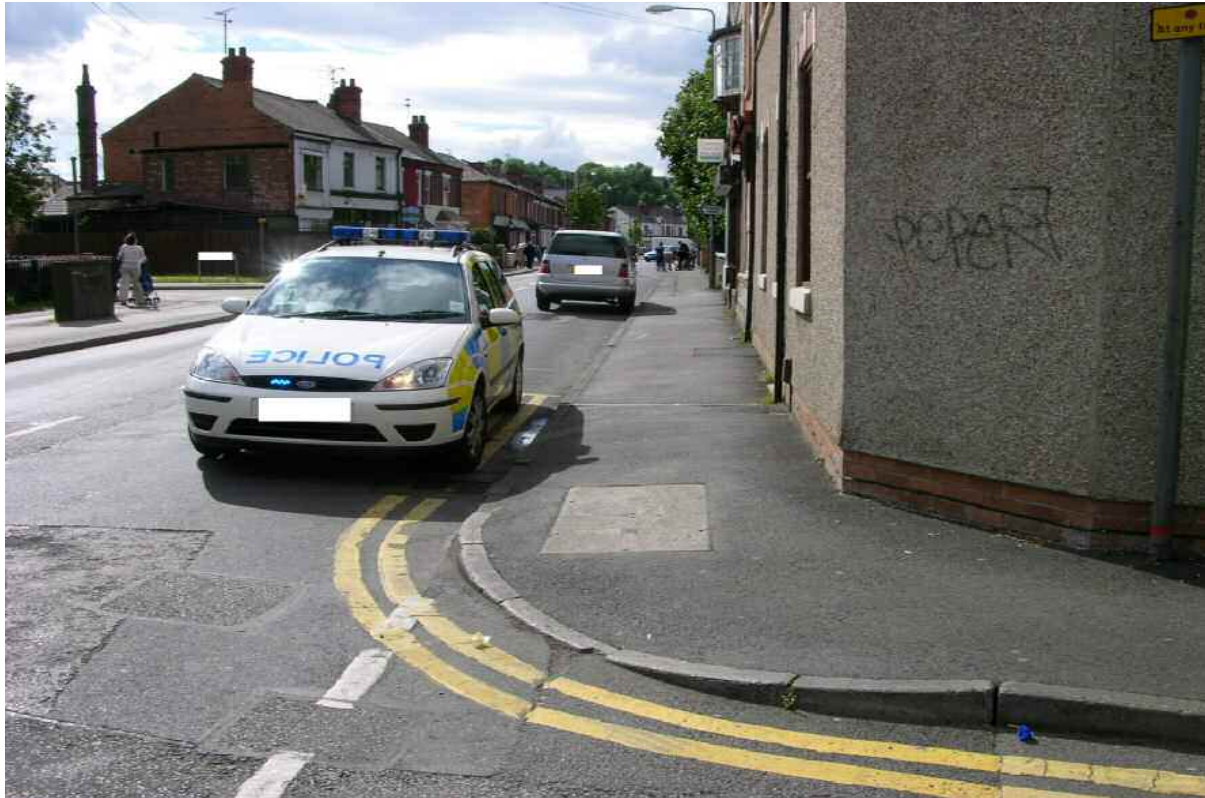
Figure 47: A Stationary Police Car Demonstrates the position of the Illegally Parked Car

The moped and rider were travelling along the main road in an easterly direction and it is assumed that the rider had to take a wider path than anticipated to go around the parked car. At this point, the moped was travelling at 25 mile/h. The picture in figure 47 shows a police car, which attended the scene, positioned in the same place as the parked car at the time of the accident. As the driver of the Vauxhall Corsa crept forward, he began his right turn manoeuvre, but failed to see the approaching moped rider who struck the front offside of the car. The moped rider had applied the brakes before the impact and was travelling at an estimated 15 mile/h at the point of collision.

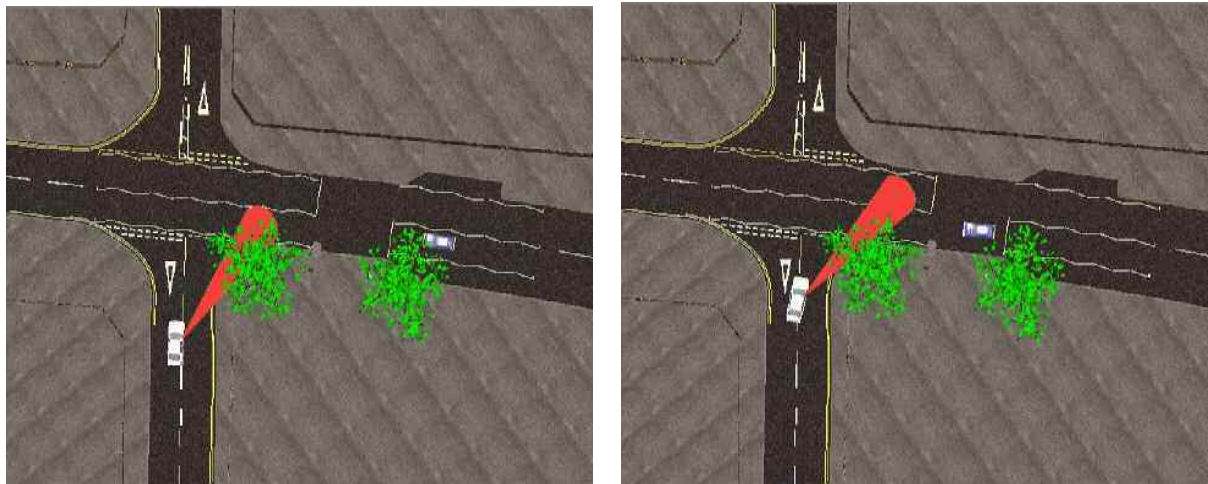
Figures 50 and 51: Plan View of the Mercedes and Honda Approaching the Junction

Figures 50 and 51 show the Honda Civic was not obscured by the offside 'A' pillar of the Mercedes as it approached the junction even though the area of 'A' pillar obscuration is more towards the Honda than it would have been if the Mercedes had not cut the corner. The Mercedes driver had already committed to the right turn by the point where the Honda is obscured by the Mercedes offside 'A' pillar. However, had the 'A' pillar not obscured the view of the Mercedes driver, he may have been able to brake sooner in an effort to avoid the collision.

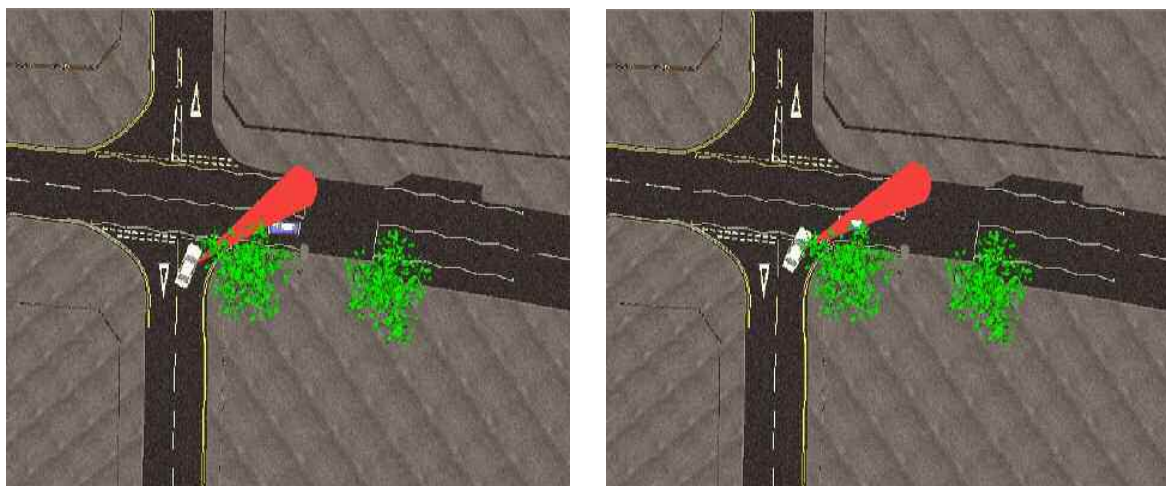
Figures 52 and 53: Plan Views of Mercedes Starting a Right Turn from the Junction

Figures 52 and 53 show how the Honda Civic is obscured by the offside 'A' pillar of the Mercedes as it pulls out from the junction.

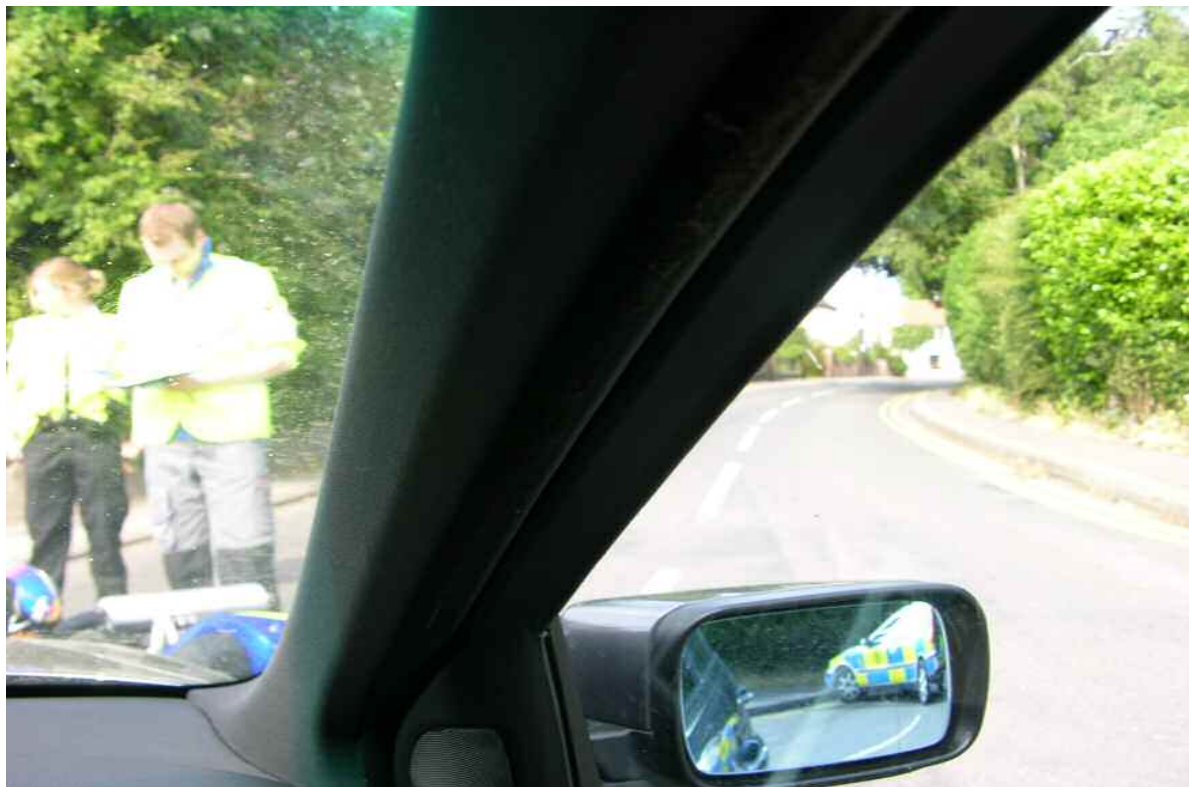
Figure 54: View of the Offside 'A' Pillar taken from the Drivers Seat

Case 9 occurred at a T-junction in a village. There were two vehicles involved: a 2 year old BMW 320 and a Suzuki R600 motorcycle. The BMW was driven by a female, 5 ft 4'' The BMW has a particularly thick 'A' pillar, flared at the bottom, which would have been in the region the driver of the BMW may have been looking.

Figure 54 is a photograph of the offside 'A' pillar taken from the driver's seat. Although this is a rather distorted view of the 'A' pillar, as the photographer was looking directly through it when the photograph was taken, it does illustrate the amount of obscuration by the offside 'A' pillar; the nearside carriageway is almost completely hidden.

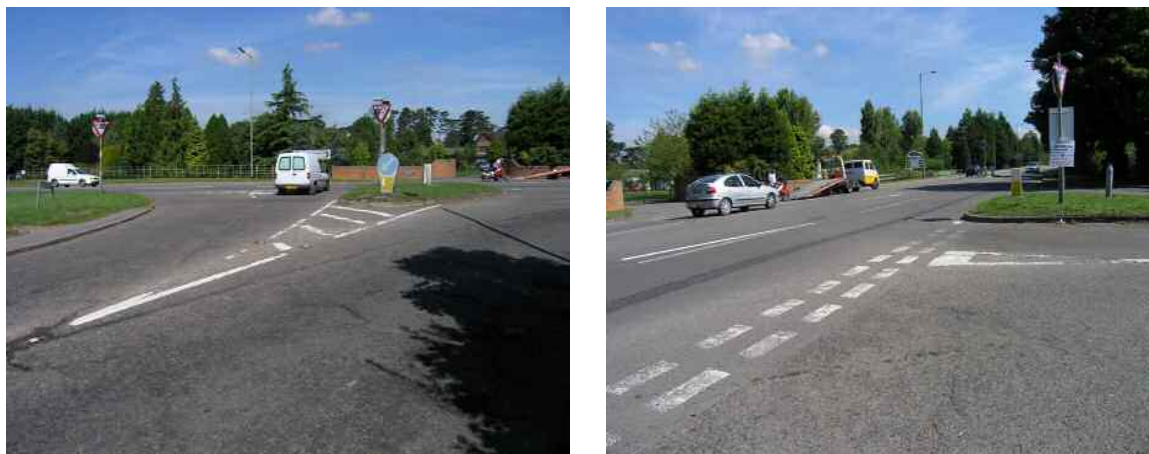
Figure 58 and 59: Views of the Junction and the Intended Direction of the Volvo 850

The driver of the Volvo 850 approached the junction and remained there stationary for some time, waiting for a gap in the traffic to allow him to turn right. Eventually, the driver saw a chance to pull out from the junction and turn right. At this point the motorcyclist was travelling on the main road that adjoined the country road the Volvo was turning from. As the Volvo pulled out of the junction, the motorcyclist tried to steer to the right in an attempt to avoid the car. Both vehicles collided; the front offside of the Volvo struck a glancing blow to the motorcyclist.

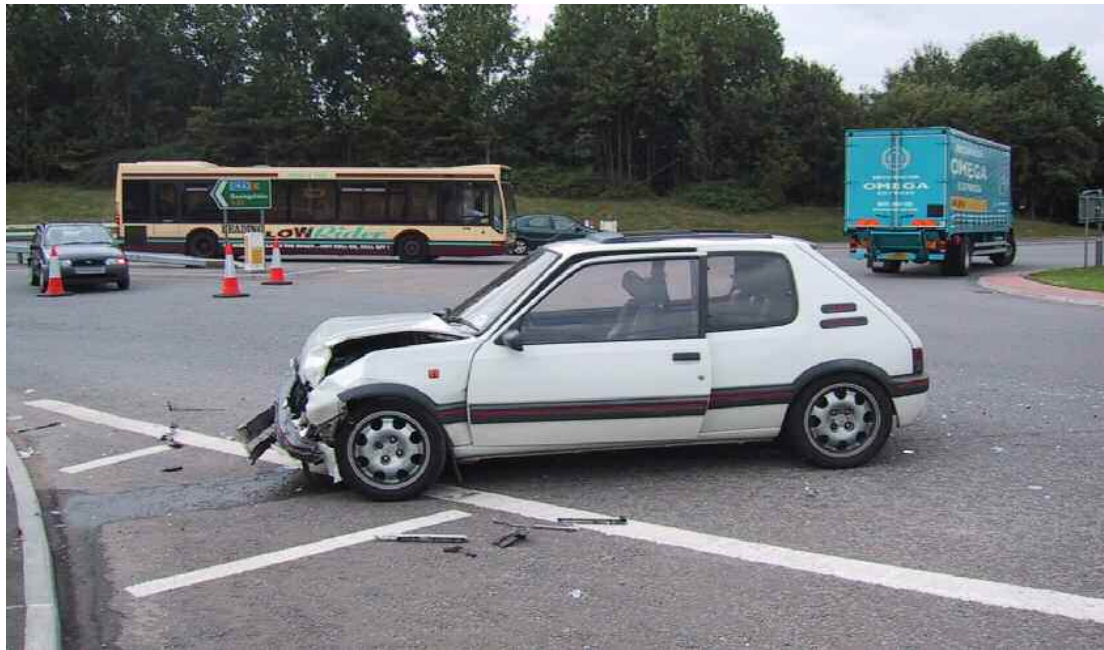
Figure 71: Damage to Peugeot

In this case a Peugeot 205 was travelling around a roundabout. A Ford Fiesta failed to give way on entering the roundabout, causing the front of the Peugeot to impact directly with the off side doors of the Fiesta.

The accident occurred because the Fiesta pulled onto the roundabout and into the path of the Peugeot. The crash speed was moderate and neither car appears to have had time to take any evasive action. The driver of the Ford Fiesta was given an interaction code of “Looked but Did Not See”, which led us to believe this could have been an ‘A’ pillar related incident. This case and others have given some confidence to this approach.

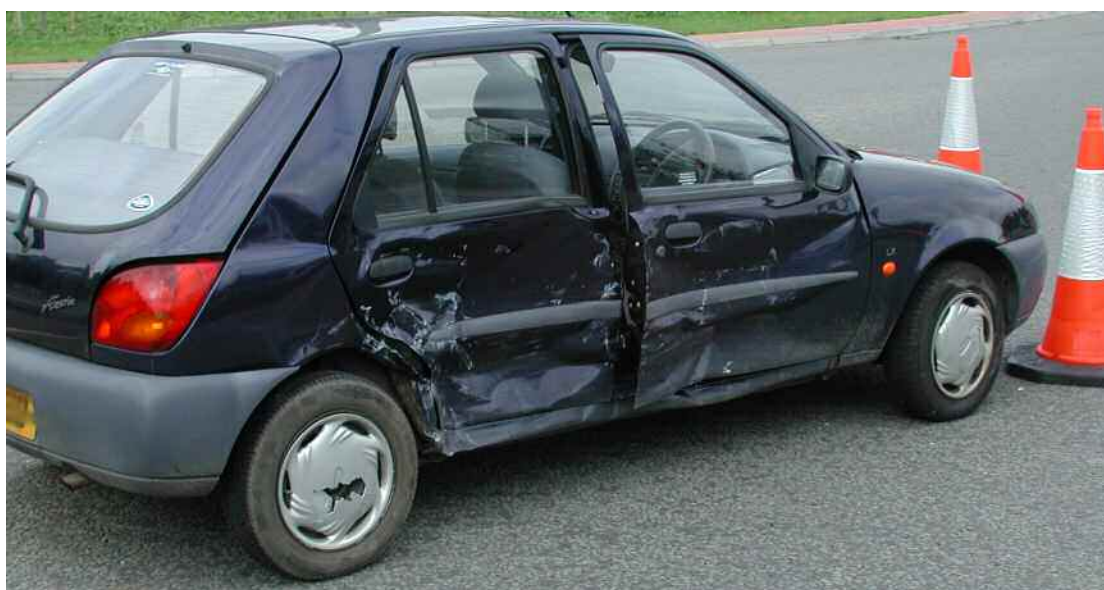
Figure 72: Damage Sustained by the Ford Fiesta

The damage to the Fiesta shows that it was struck on the off side doors behind the front wing with direct contact damage as far back as the ‘C’ pillar (see photograph, below). The condition of the carriageway for both cars is noted as dry and there are no recorded skid marks on either car’s path.
