Pelvic Injury Mechanisms among Motorcyclists

Lauren Meredith, Matthew Baldock, Michael Fitzharris, Julie Brown

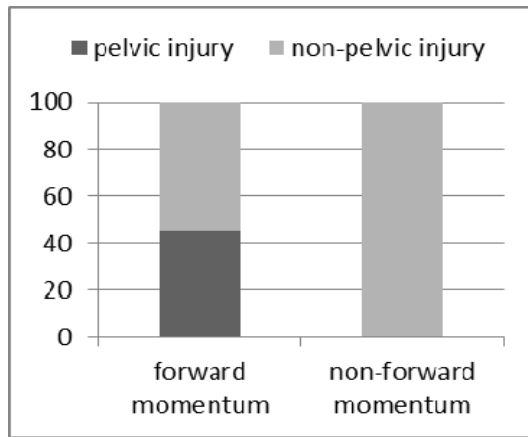
Figure 1. Occurrence of pelvic injury in forward momentum cases

The petrol tank was the cause of pelvic injury in 27 cases (90%). There were a further three cases where the rider reported they had impacted the fuel tank and denting of the fuel tank was observed in two of these, but no injury occurred. Pelvic injuries due to the fuel tank only occurred in collisions where the rider experienced forward momentum following impact. Among the 139 cases, a total of 60 riders experienced forward momentum following impact and 45% of these sustained pelvic injury – see Figure 1. All except two of the riders were ejected from the motorcycle following the collision.

Motorcycles ridden by riders who suffered pelvic injuries from the fuel tank (n=27) were predominantly sports motorcycles (n=13), followed by cruisers (n=8), standards (n=4), touring (n=1) and café racers (n=1). Looking at the 60 cases where riders experienced forward momentum post impact, pelvic injury occurred more often in cruisers (80%) than in other motorcycle types (45%) – see Figure 2. Controlling for motorcycle type, the likelihood of pelvic/abdominal injury significantly increased with increasing petrol tank angle ($p < 0.05$).

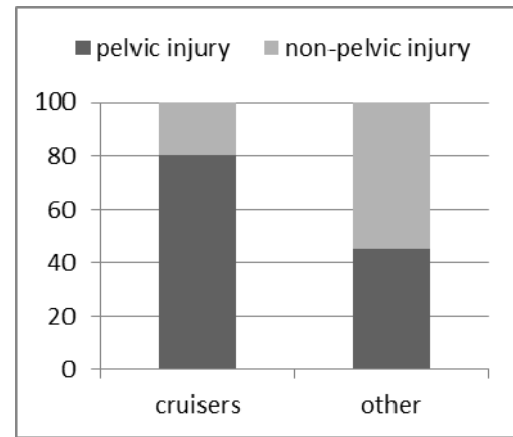
Figure 2. Number of pelvic injuries on different motorcycle types

It was noted that riders of cruisers were more likely to sustain a pelvic injury than other motorcycle types. This appears to contradict the relationship between the petrol tank angle and level of pelvic loading reported by Wobrock et al. [3], as cruisers have a more gradual incline. However, it more likely represents two different mechanisms of injury associated with petrol tank contact. Pelvic injury in cruiser riders may be dependent on other fuel tank dimensions and/or rider posture, with the legs stretched out and the rider upright instead of leaning forward over the fuel tank. This posture may change the rider kinematics with the rider more likely to slide forward into the tank than be ejected upward and over the handlebars as is more likely to be the case in sports bikes etc. This latter mechanism is likely to be more reliant on tank angle and is supported by our observation that tank angle is significant when motorcycle type is controlled.
