Virginia Commonwealth University Transportation Safety Training Center

Crash Investigation Team

Special Report Number 18 - December 2004

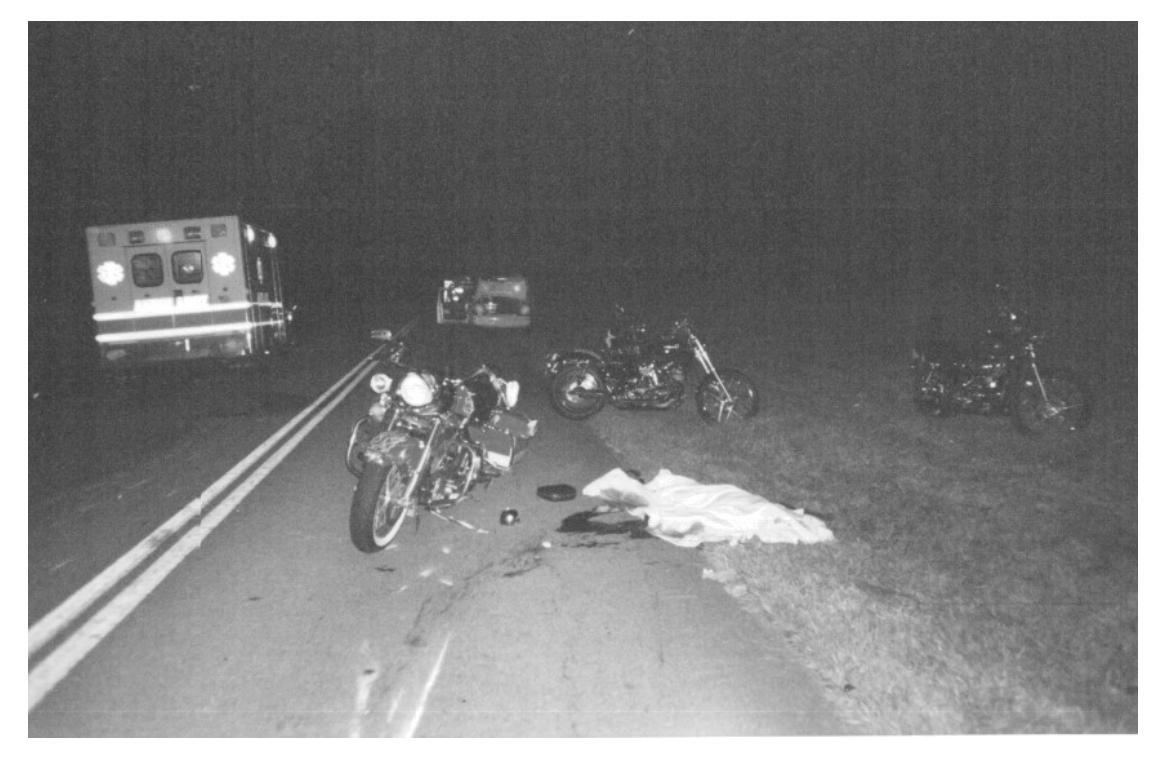
Photo No. 1: View looking north at the final rest of the crash involved motorcycles and the fatally injured female victim.

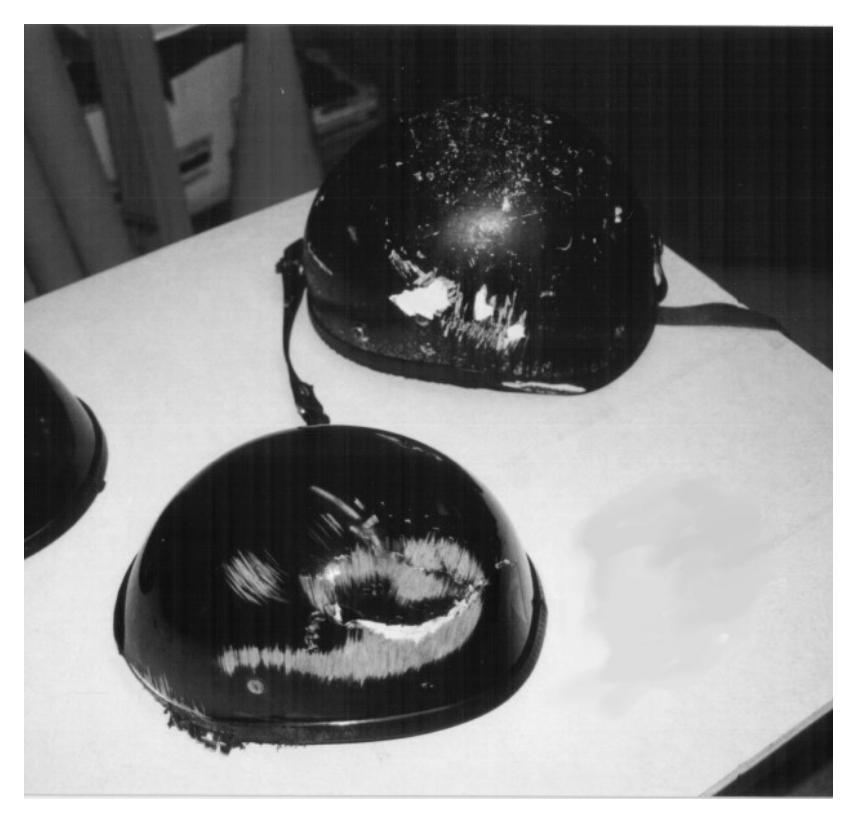
Both the black and red motorcycle drivers came to rest with their helmets still on their heads. These non-DOT approved helmets displayed obvious exterior damage to their shells. The black motorcycle riders' helmet was a heavy, full head style, police-issue riot helmet intended to be worn by police officers during riots and demonstrations. Its full interior liner was heavily padded although not of the design and type of an approved motorcycle safety helmet. This helmet incurred heavy scrapes and scratches and part of the shell on its left side was shattered. The chinstrap and metal retention clasp were intact and did not fail during the collision. This rider received several minor abrasions and contusions to his arms and legs, but he incurred no head or face injuries in the collision. He was examined at the scene by rescue personnel and released.

Photo No. 2: View of the two non-DOT approved helmets worn by the two motorcycle operators. Note the damages on each helmet.

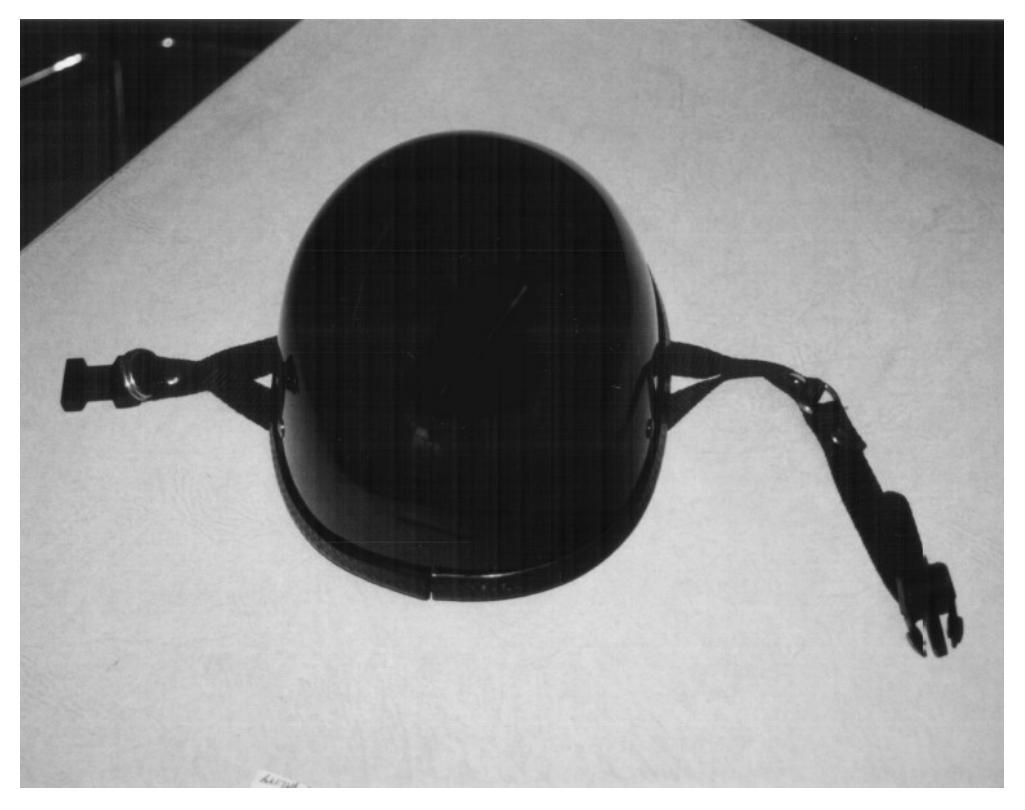
Photo No. 3: View of the non-DOT approved helmet (novelty type) owned, but not worn, by the fatally injured female victim. It is free of any damage.

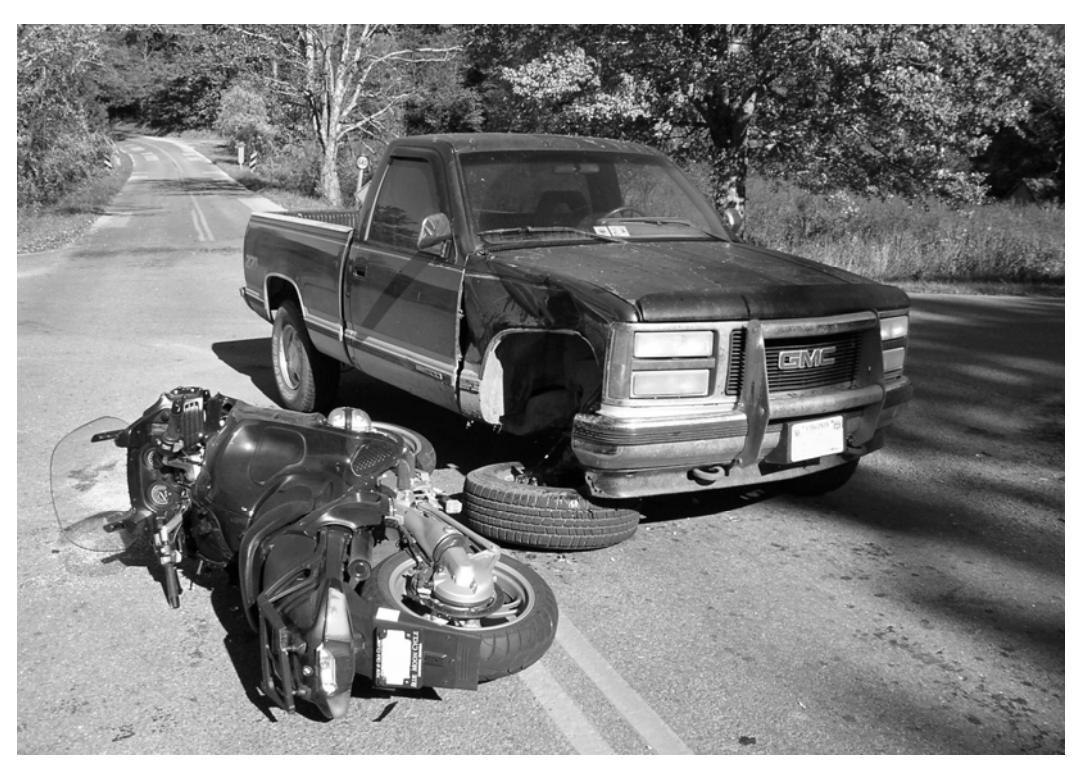
Photo No. 4: View of final rest of the pickup and motorcycle. Note damage to pickup's right front fender and wheel areas. Both motorcycle riders vaulted over the pickup's hood after impact and came to rest on pavement beyond the pickup.

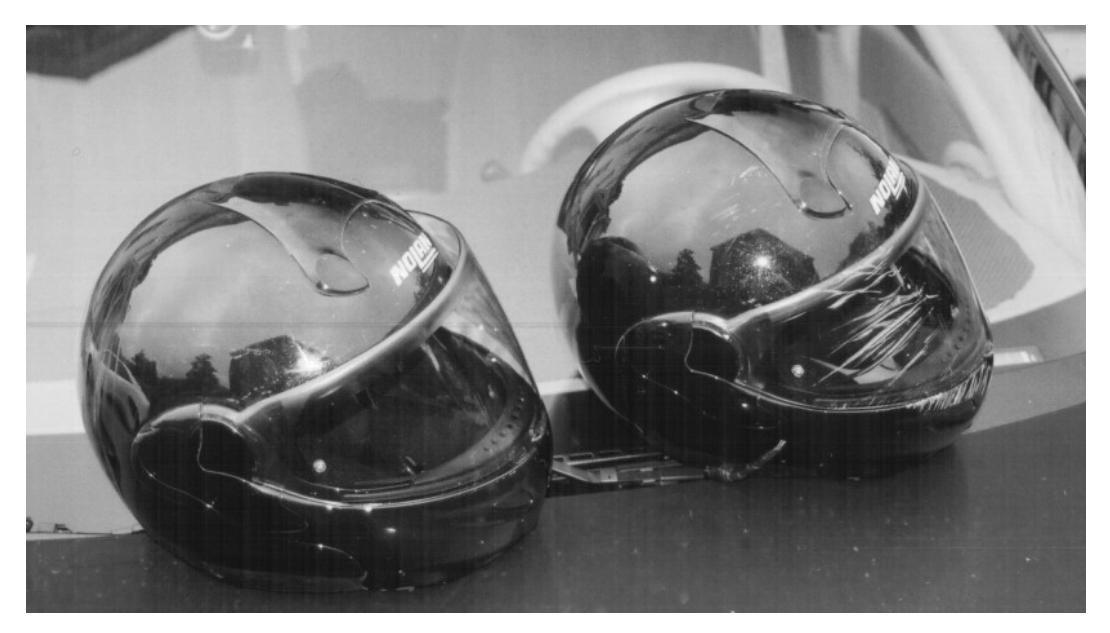
The two helmets were examined by the Crash Investigation Team. The female's helmet displayed the most damage. The right side and center of the chin portion and face shield were badly scraped from contact with the asphalt. Additional road abrasions were noted on the top right half of the helmet. The chinstrap, buckle and full-face shield remained intact. No visible damages and/or blood, hair, or tissue were detected on the interior. The male's helmet displayed damage to the left side face shield connection point and scratches/smudges detected on its left lower chin portion, rear top and midsection and right topside midsection. The chinstrap and buckle assembly were intact and undamaged. No damage or blood/tissue was detected on the

interior, although it appeared somewhat worn. The condition of this helmet revealed that it was apparently used more than the wife's helmet.

Photo No. 5: View of both DOT approved helmets worn by both riders involved in the crash. The operators' helmet is on the left and his rider's helmet on the right. Both helmets incurred significant damage from striking the pavement after the collision.
